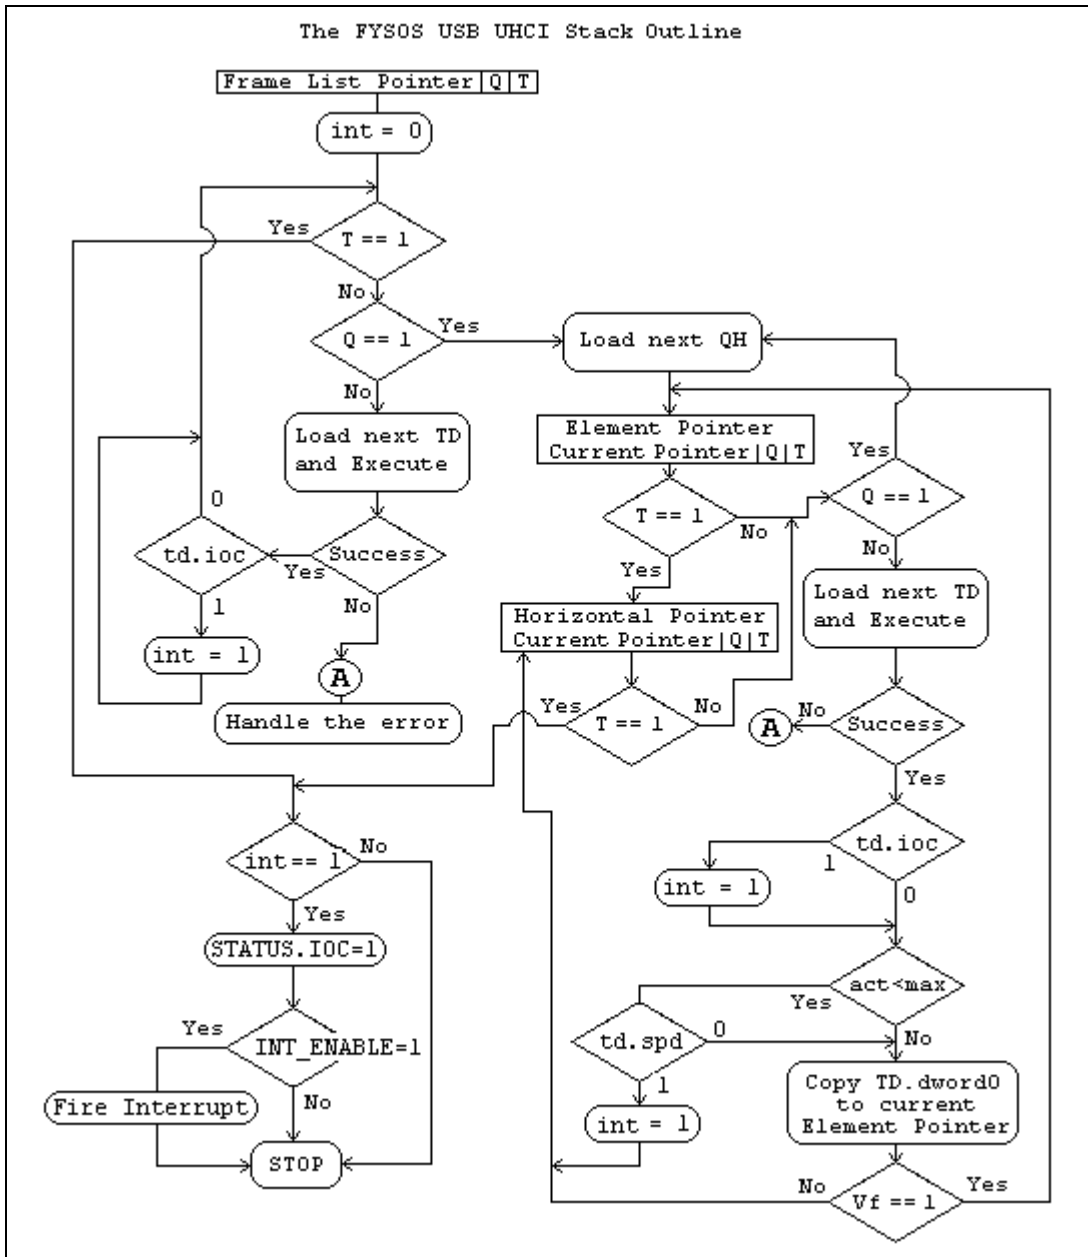
Outline 4-1: The UHCI Process

It seems that the way I was describing the UHCI's stack was quite confusing to some people, so I have reworded it and updated the outline at the end of chapter 4. See the next page for the modified outline.
